Subject: **NPDES Construction General Permit Tracking No. TNR111881**
Southeastern Tennessee State Regional Correctional Facility (also known as
Bledsoe County Correctional Complex)
State of Tennessee - Department of Finance and Administration
Pikeville, Bledsoe County, Tennessee

Compliance Inspection for General NPDES Permit for Stormwater Discharges from Construction Activities (CGP)

Site/Project Name: Southeastern Tennessee State Regional Correctional Facility (also known as Bledsoe County Correctional Complex)		NPDES Tracking Number: TNR111881	
Street Address or Location: 1045 Horsehead Road		Start date:	24-MAY-11
		Estimated end date:	24-JUL-12
Site Description: Construction of a wastewater treatment plant with all parking, roads, utilities and storm water system.		Latitude (dd.dddd):	35.7375
		Longitude (-dd.dddd):	-85.25
County(ies): Bledsoe	EFO: Chattanooga	MS4 Jurisdiction:	Acres Disturbed: 9
		Total Acres:	
Name of Permittee (Developer/Operator): State of Tennessee - Department of Finance and Administration			
Name of Official Contact: Tim Huddleston		Email: thuddleston@wocc.com	Contact Phone: 931-403-5311
Address: 150 Construction Drive		City: Livingston	State: TN Zip:

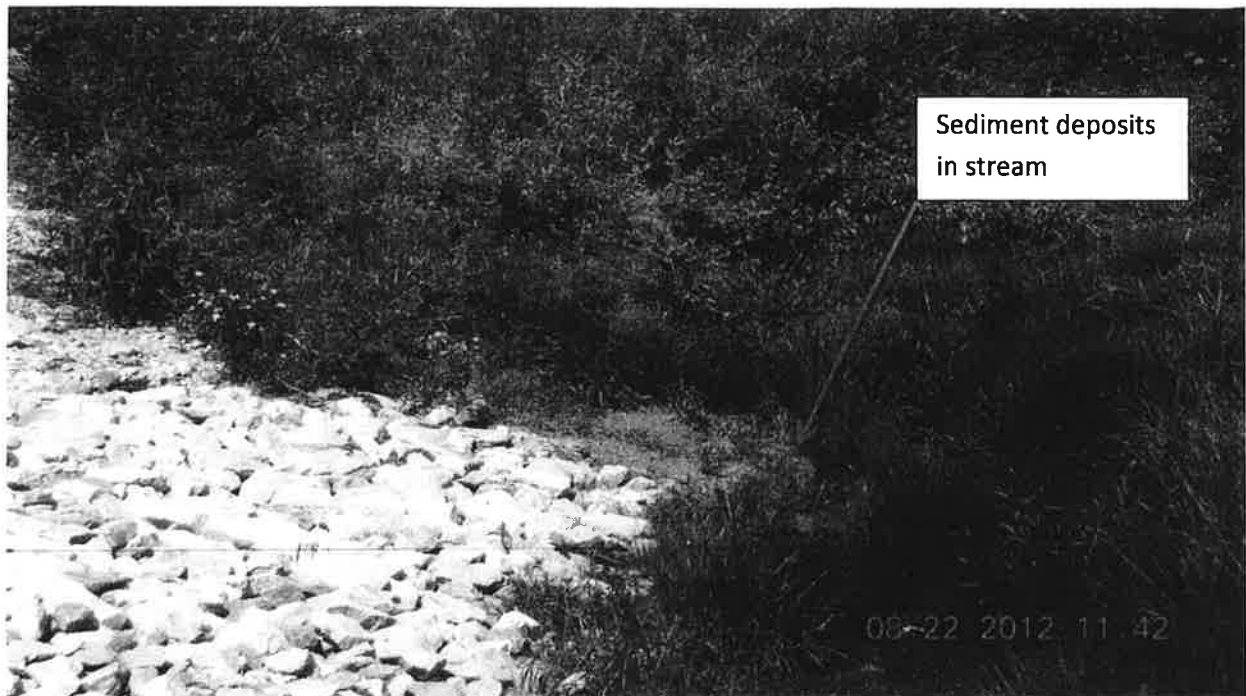
11	Has sediment discharged off site?	<input checked="" type="checkbox"/>	<input type="checkbox"/>
12	Has sediment discharged into waters of the State?	<input checked="" type="checkbox"/>	<input type="checkbox"/>
13	Are there unauthorized alterations to waters of the State?	<input type="checkbox"/>	<input checked="" type="checkbox"/>
14	Are there violations of an existing ARAP? If so, ARAP No.?	<input type="checkbox"/>	<input checked="" type="checkbox"/>
15	Other pollutants/discharges or unusual problems?	<input type="checkbox"/>	<input checked="" type="checkbox"/>
General Comments: Sediment has migrated into Mill Creek. The sediment deposits within the creek must be removed by hand tools only. Please remove the sediment as soon as possible to avoid possible future enforcement action. Also, remove any other sediment deposits below the existing silt fencing. Repair or replace the silt fencing near Mill Creek that has been compromised leading to the sediment discharge.

Photograph 1: Remove the sediment deposits from the stream using hand tools only.
